# Efficacy of RotStop Onsite Boron Injection Treatment

## In the Remediation of Leaky Dwellinghouses

A review of available knowledge and understanding prepared for;  
Department of Building and Housing

By Alan Light  
NZCB, MBOINZ, MNZIBS  
Alan Light Building Consultants Ltd

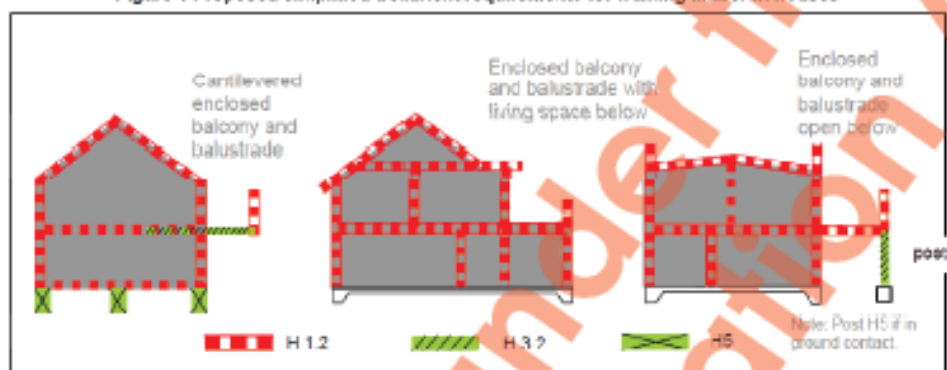
Figure 1 Proposed simplified treatment requirements for framing timber in houses

This is a similar approach and simplifies new building work with fewer differences in treatment but still illustrates the previous risk targeted approach.

Recently the DBH released a B2 consultation document<sup>8</sup> on proposal to simplify the hazard class including a single H1.2 hazard class for all framing except for cantilevered decks (refer appendix) DBH - B2 consultation document - Sept 2010
